**Flood Control Project Maintenance  
Levee Inspections**

**Fall 2016 Levee Maintenance Deficiency Summary Report**

**Reclamation District No. 0817 Carlin**

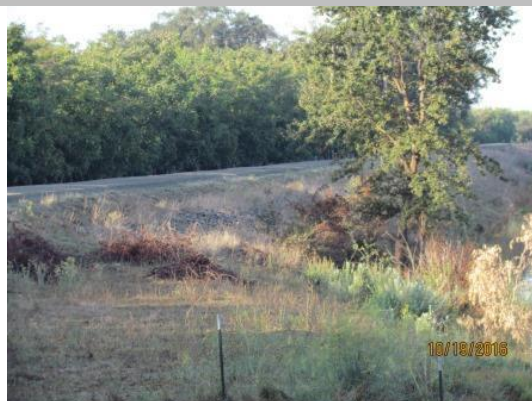
Photo 1 of 1 : FA\_2016\_RD0817\_12\_27\_20161025\_00018.jpg

View of well maintained vegetation on the waterside looking downstream. Fall 2016.

LM Start	0.00	Rating **	A	Issue No.	26
LM End	3.72	Issue Type +	Ma	Location *	LS
Category	Earthen Levee			GPS Latitude/Longitude	
				Start	End
Item	Vegetation			38.984674 °	39.019129 °
				-121.506111 °	-121.455623 °
DWR ID	DWR_RD0817_01_f_2016_26				
Comment Code					
V1 : Control annual grass and weeds on the levee slopes and easements.					
Inspector Comment					
Well maintained vegetation, Fall 2016.

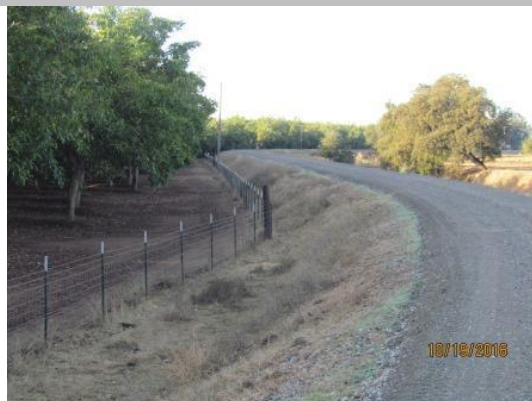
Photo 1 of 1 : FA\_2016\_RD0817\_12\_26\_20161025\_00019.jpg

View of well maintained vegetation on the landside looking downstream. Fall 2016.

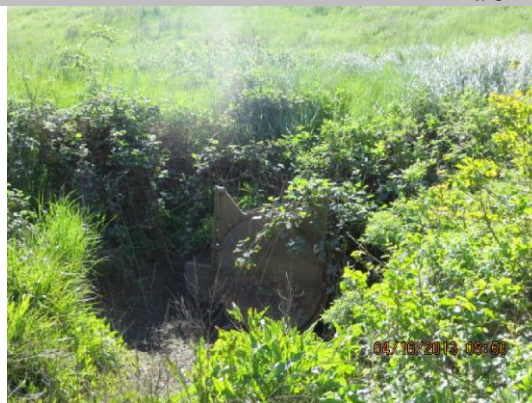
Photo 1 of 2 : UCIP\_FA\_2016\_42685\_19865.jpg

LM Start	0.29	Rating **	M	Issue No.	32
LM End	0.29	Issue Type +	En	Location *	WS
Category	Supplemental			GPS Latitude/Longitude	
				Start	End
Item	DWR UCIP Field Study			38.987813 °	38.987813 °
				-121.502963 °	-121.502963 °
DWR ID					
Comment Code					
Inspector Comment					
FS_ID:42685 DS_ID:18985 EP_NO: N/A Repair Type: Non-Urgent Crossing Status: Found UCIP Comments: Dense vegetation on waterward and landward slopes limit visual inspection of potential leaks along pipe alignment. Recommend having owner clear vegetation along slopes. FIELD_STRUCT_DESC: 48-inch corrugated metal drainpipe through levee, 23.3 feet below the crown. Flap gate on waterward end. FS Date: 4/16/2013

WS- pipe, flap gate in dense vegetation on berm

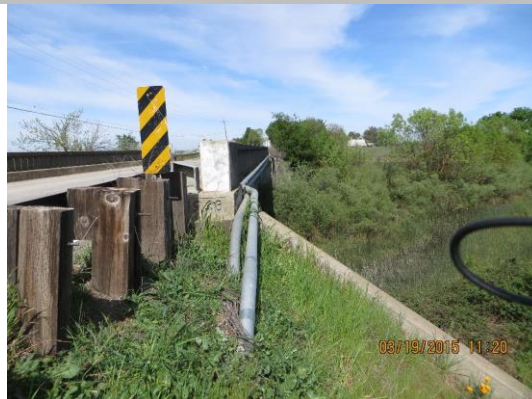
Photo 1 of 2 : UCIP\_FA\_2016\_44084\_73565.jpg

LM Start	1.13	Rating **	M	Issue No.	46
LM End	1.13	Issue Type +	En	Location *	WS
Category	Supplemental			GPS Latitude/Longitude	
				Start	End
Item	DWR UCIP Field Study			38.995667 °	38.995667 °
				-121.490981 °	-121.490981 °
DWR ID					
Comment Code					
Inspector Comment					
FS_ID:44084 DS_ID:25088 EP_NO: N/A Repair Type: Non-Urgent Crossing Status: Found UCIP Comments: No permit identified for this crossing. FIELD_STRUCT_DESC: 4-inch steel communication conduit through the levee, 4 feet below levee crown. FS Date: 3/19/2015

Communication conduit visible on upstream side of bridge.

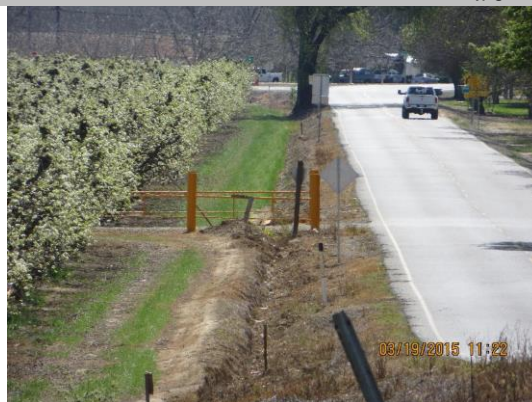
Photo 2 of 2 : UCIP\_FA\_2016\_44084\_73564.jpg

Fiberoptic line markers along roadway to south of bridge.

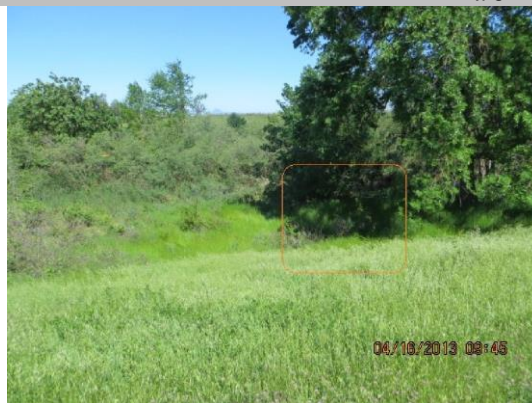
Photo 1 of 2 : UCIP\_FA\_2016\_41153\_19882.jpg

Comment Code					
Inspector Comment					
FS_ID:41153 DS_ID:18987 EP_NO: N/A Repair Type: Non-Urgent Crossing Status: Found UCIP Comments: Damaged slide gate on WS of the levee. Need to contact owner to determine status of crossing. If crossing is no longer in use owner will need to contact CVFPB to comply with Title 23. Dense vegetation on waterward and landward slopes limit visual inspection of potential leaks along pipe alignment. Recommend having owner clear vegetation along slopes. FIELD_STRUCT_DESC: *ABANDONED* 18-inch corrugated metal drainpipe through levee, 14.9 feet below the crown. Slide gate on the waterward end. O&M Manual Sac 146, November 1962. FS Date: 4/16/2013

WS- overview of WS area

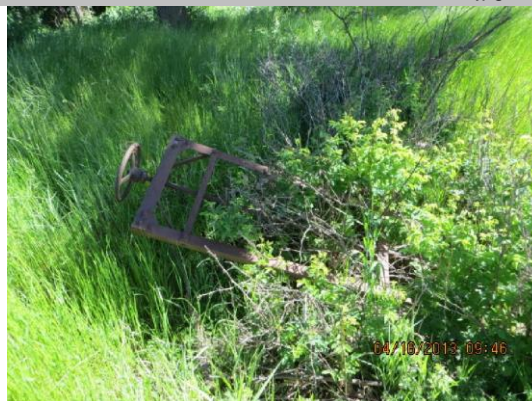
Photo 2 of 2 : UCIP\_FA\_2016\_41153\_19881.jpg

Comment Code						
Inspector Comment						
FS_ID:41153 DS_ID:18987 EP_NO: N/A Repair Type: Non-Urgent Crossing Status: Found UCIP Comments: Damaged slide gate on WS of the levee. Need to contact owner to determine status of crossing. If crossing is no longer in use owner will need to contact CVFPB to comply with Title 23. Dense vegetation on waterward and landward slopes limit visual inspection of potential leaks along pipe alignment. Recommend having owner clear vegetation along slopes. FIELD_STRUCT_DESC: *ABANDONED* 18-inch corrugated metal drainpipe through levee, 14.9 feet below the crown. Slide gate on the waterward end. O&M Manual Sac 146, November 1962. FS Date: 4/16/2013

WS- closer look at damaged slide gate on WS

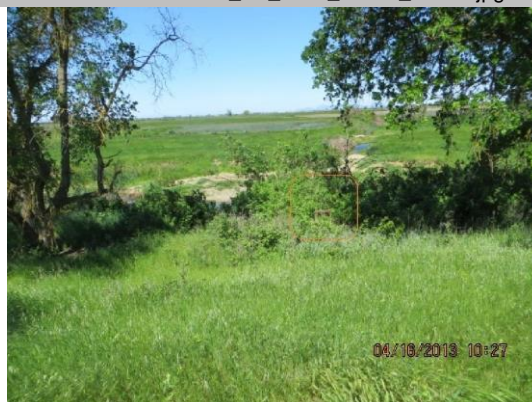
Photo 1 of 2 : UCIP\_FA\_2016\_41157\_19892.jpg

Comment Code					
Inspector Comment					
FS_ID:41157 DS_ID:18988 EP_NO: N/A Repair Type: Non-Urgent Crossing Status: Found UCIP Comments: A burried slide gate on WS of the levee. Need to contact owner to determine status of crossing. If crossing is no longer in use owner will need to contact CVFPB to comply with Title 23. Dense vegetation on waterward and landward slopes limit visual inspection of potential leaks along pipe alignment. Recommend having owner clear vegetation along slopes. FIELD_STRUCT_DESC: *ABANDONED* 18-inch corrugated metal drainpipe through the levee, 14.9 feet below the crown. Slide gate on the waterward end. O&M Manual Sac 146, November 1962. FS Date: 4/16/2013

WS- overview of WS berm

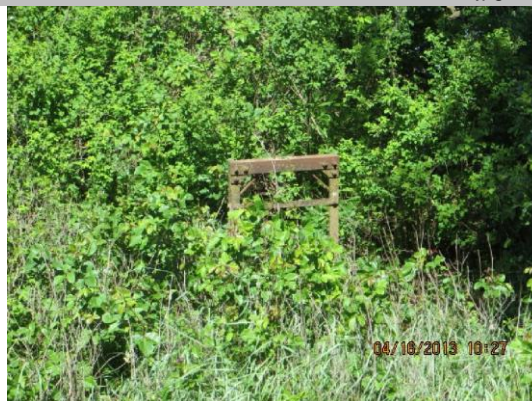
Photo 2 of 2 : UCIP\_FA\_2016\_41157\_19891.jpg

Comment Code						
Inspector Comment						
FS_ID:41157 DS_ID:18988 EP_NO: N/A Repair Type: Non-Urgent Crossing Status: Found UCIP Comments: A burried slide gate on WS of the levee. Need to contact owner to determine status of crossing. If crossing is no longer in use owner will need to contact CVFPB to comply with Title 23. Dense vegetation on waterward and landward slopes limit visual inspection of potential leaks along pipe alignment. Recommend having owner clear vegetation along slopes. FIELD_STRUCT_DESC: *ABANDONED* 18-inch corrugated metal drainpipe through the levee, 14.9 feet below the crown. Slide gate on the waterward end. O&M Manual Sac 146, November 1962. FS Date: 4/16/2013

WS- slide gate

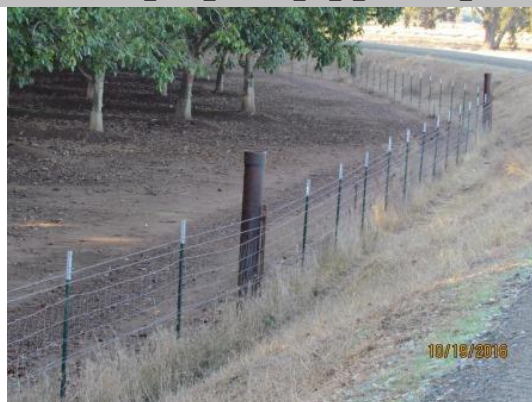
Photo 1 of 1 : FA\_2016\_RD0817\_12\_8\_20161025\_00017.jpg

LM Start	1.74	Rating **	M	Issue No.	8
LM End	3.81	Issue Type +	En	Location *	LS
Category	Earthen Levee			GPS Latitude/Longitude	
				Start	End
Item	Encroachments			39.002941 °	39.019763 °
				-121.484856 °	-121.454151 °
DWR ID	DWR_RD0817_01_s_2013_8				
Comment Code					
FE : Fence					
Inspector Comment					
Wire fence at L/S levee toe. Fall 2016.

Wire fence at L/S levee toe. Fall 2016.

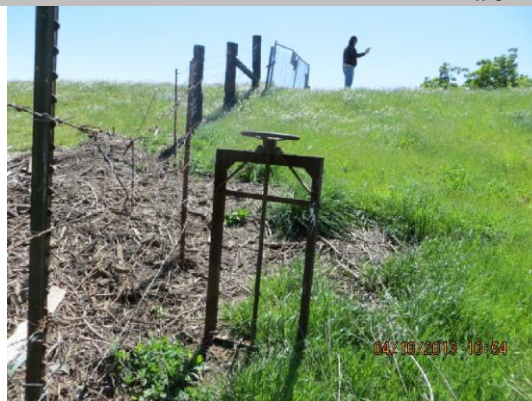
Photo 1 of 1 : UCIP\_FA\_2016\_41156\_19895.jpg

Comment Code					
Inspector Comment					
FS_ID:41156 DS_ID:18989 EP_NO: N/A Repair Type: Non-Urgent Crossing Status: Indicator Found UCIP Comments: A burried slide gate found on WS. Need to contact owner to determine status of crossing. If crossing is no longer in use owner will need to contact CVFPB to comply with Title 23. Dense vegetation on waterward and landward slopes limit visual inspection of potential leaks along pipe alignment. Recommend having owner clear vegetation along slopes. FIELD_STRUCT_DESC: *ABANDONED* 8-inch corrugated metal drainpipe through levee, 11.7 feet below the crown. Slide gate on the waterward end. O&M Manual Sac 146, November 1962. (Permit 16193, 1994, was issued for the removal of this crossing, but slidegate appears to remain on WS toe. FS Date: 4/16/2013

WS- slide gate on levee toe.

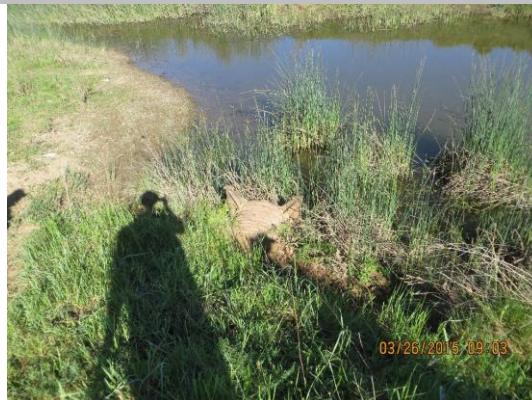
Photo 1 of 2 : UCIP\_FA\_2016\_43946\_73422.jpg

Pipe and flapgate visible on WS toe.

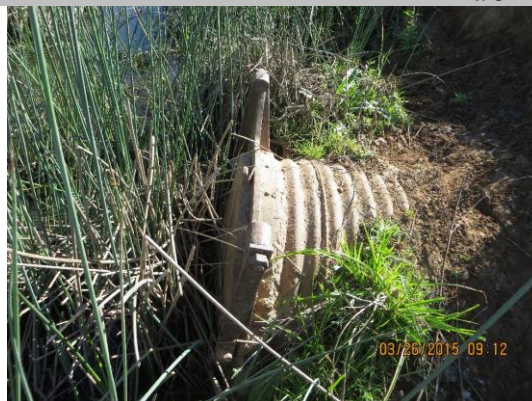
Photo 2 of 2 : UCIP\_FA\_2016\_43946\_73421.jpg

Pipe and flapgate visible on WS toe.

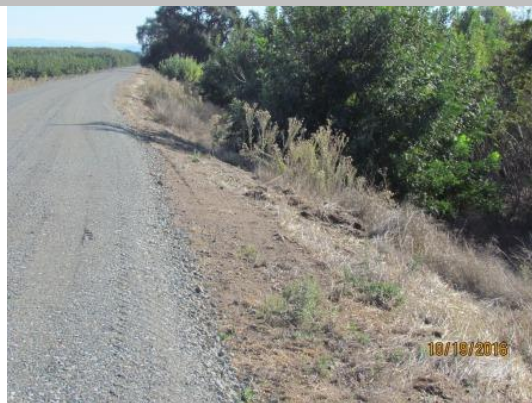
Photo 1 of 1 : FA\_2016\_RD0817\_13\_14\_20161025\_00020.jpg

View of annual grass that needs to be maintained on the waterside looking upstream, Fall 2016.

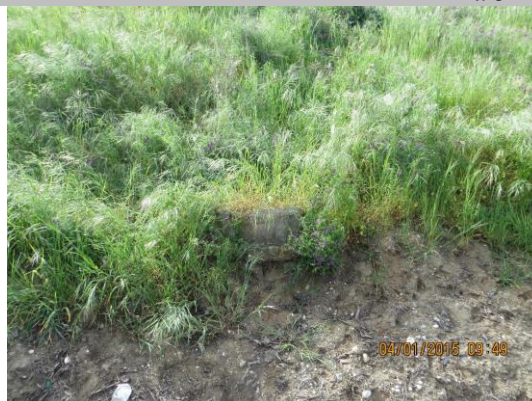
Photo 2 of 2 : UCIP\_FA\_2016\_44064\_73541.jpg

Concrete standpipe visible on lower slope of LS toe.

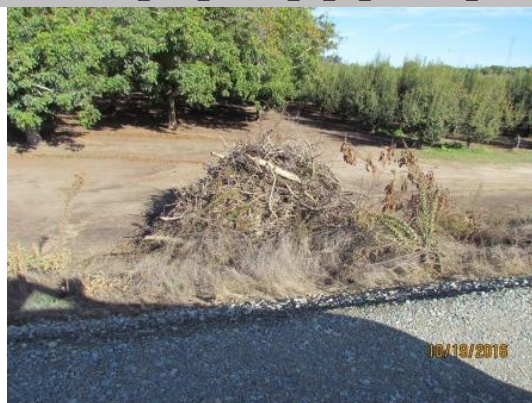
Photo 1 of 1 : FA\_2016\_RD0817\_13\_16\_20161025\_00023.jpg

View of pruning pile at landside levee toe. Fall 2016.

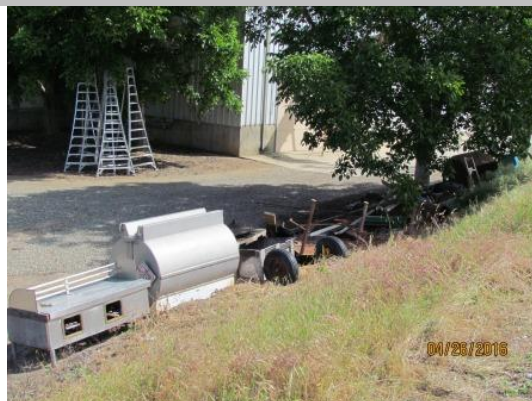
Photo 1 of 1 : FA\_2016\_RD0817\_13\_3\_20160906\_00001.jpg

Photo of equipment encroaching onto the landside toe. This is still the same for Fall 2016 inspection.

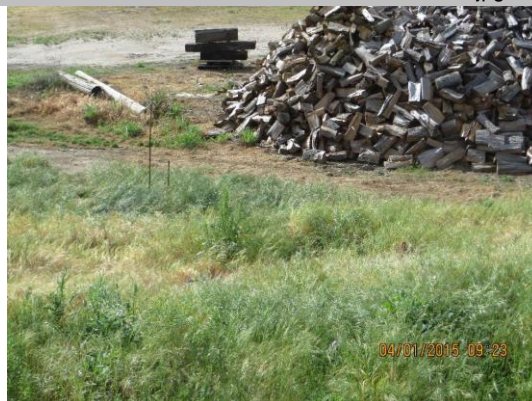
Photo 1 of 2 : UCIP\_FA\_2016\_46182\_74559.jpg

LM Start	2.05	Rating **	M	Issue No.	21
LM End	2.05	Issue Type +	En	Location *	LS
Category	Supplemental			GPS Latitude/Longitude	
				Start	End
Item	DWR UCIP Field Study			38.989212 °	38.989212 °
				-121.469137 °	-121.469137 °
DWR ID					
Comment Code					
Inspector Comment					
FS_ID:46182 DS_ID:25095 EP_NO: N/A Repair Type: Non-Urgent Crossing Status: Found UCIP Comments: Need to determine permit for crossing. FIELD_STRUCT_DESC: 2-inch galvanized iron waterline through the levee at an unknown depth below the crown. Hose bib at WS toe. Possible connection at building corner on LS. FS Date: 4/1/2015

Pipe and hose bib visible in tall grass at WS toe.

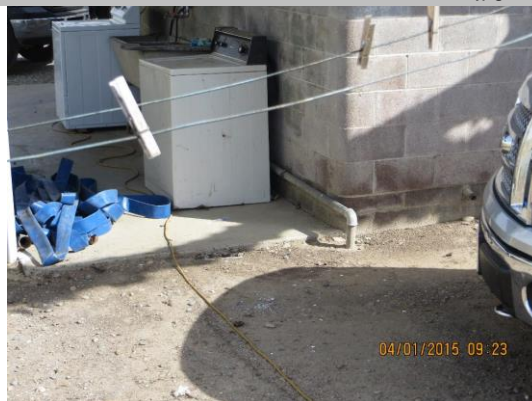
Photo 2 of 2 : UCIP\_FA\_2016\_46182\_74560.jpg

Possible source on LS at building corner.

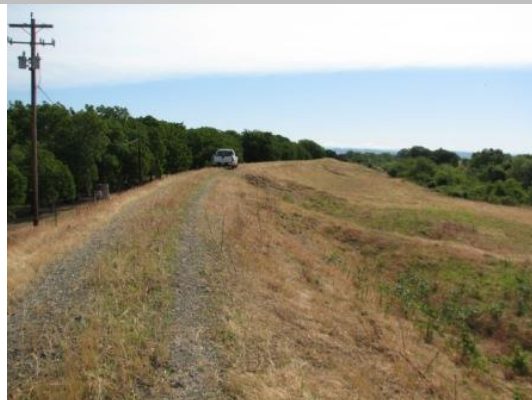
Photo 1 of 2 : FA\_2016\_RD0817\_13\_10\_20160906\_00005.jpg

LM Start	2.08	Rating **	M	Issue No.	10
LM End	3.18	Issue Type +	Ob	Location *	N/A
Category	Earthen Levee			GPS Latitude/Longitude	
				Start	End
Item	Slope Stability			38.989338 °	38.994124 °
				-121.468640 °	-121.449448 °
DWR ID	DWR_RD0817_02_s_2012_10				
Comment Code					
S1 : Repair slope instability.					
Inspector Comment					
The levee is oversteepend at this location. The LMA states that it has always been like this and the USACE did not finish constructing the levee here.

Levee mile 2.08, this photo shows the slope is less than required, this is the downstream limit of the site, this is the waterside slope.

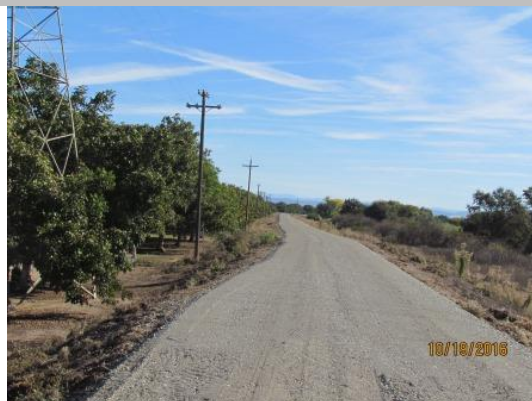
Photo 2 of 2 : FA\_2016\_RD0817\_13\_10\_20161025\_00024.jpg

Photo of approximately the same location of Fall 2016, looking upstream where the waterside slope is steep and less than required.

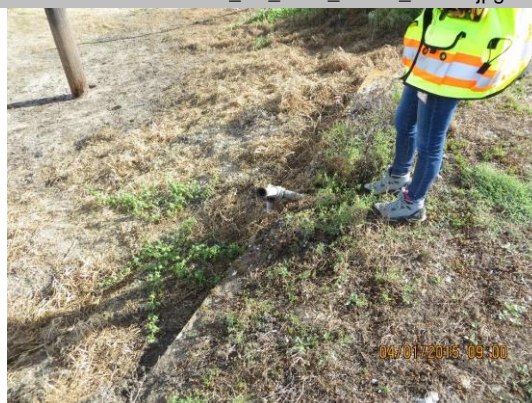
Photo 1 of 2 : UCIP\_FA\_2016\_44105\_73586.jpg

LM Start	2.11	Rating **	M	Issue No.	22
LM End	2.11	Issue Type +	En	Location *	N/A
Category	Supplemental			GPS Latitude/Longitude	
				Start	End
Item	DWR UCIP Field Study			38.989495 °	38.989495 °
				-121.468100 °	-121.468100 °
DWR ID					
Comment Code					
Inspector Comment					
FS_ID:44105 DS_ID:19010 EP_NO: N/A Repair Type: Non-Urgent Crossing Status: Found UCIP Comments: Pipe appears abandoned and should be done so properly. FIELD_STRUCT_DESC: *ABANDONED* 2-inch pipe through the levee, 1.5 feet below the crown. Concrete bulkhead on the landward slope. FS Date: 4/1/2015

Pipe visible on LS shoulder.

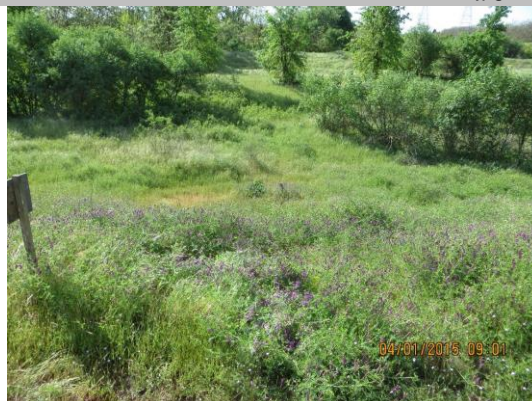
Photo 2 of 2 : UCIP\_FA\_2016\_44105\_73585.jpg

WS slope. pipe not visible.

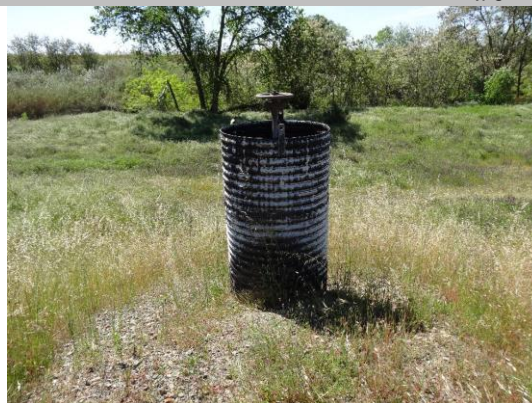
Photo 1 of 2 : UCIP\_FA\_2016\_41160\_19922.jpg

LM Start	2.38	Rating **	M	Issue No.	20
LM End	2.38	Issue Type +	En	Location *	N/A
Category	Supplemental			GPS Latitude/Longitude	
				Start	End
Item	DWR UCIP Field Study			38.990705 °	38.990705 °
				-121.463377 °	-121.463377 °
DWR ID

WS- CMP riser on levee slope.

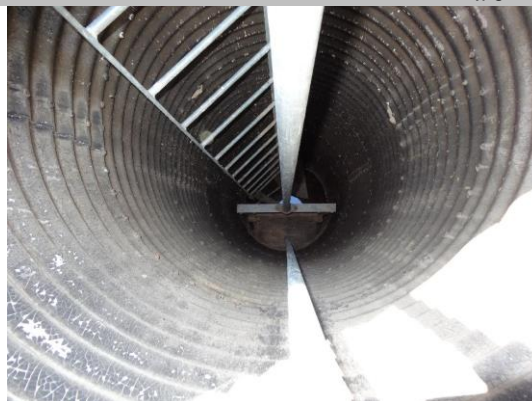
Photo 2 of 2 : UCIP\_FA\_2016\_41160\_19921.jpg

WS- inside CMP riser with air vent and slide gate.

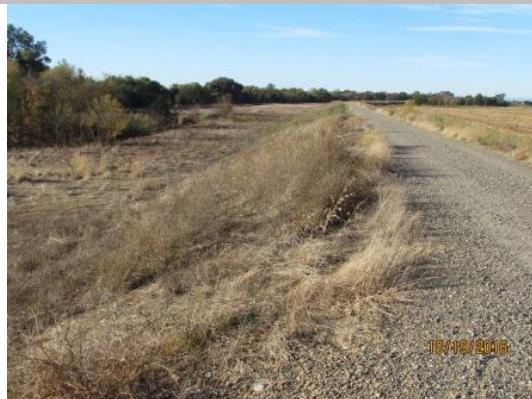
Photo 1 of 1 : FA\_2016\_RD0817\_14\_17\_20161025\_00029.jpg

View of annual grasses that need to be maintained on the waterside looking downstream. Fall 2016.

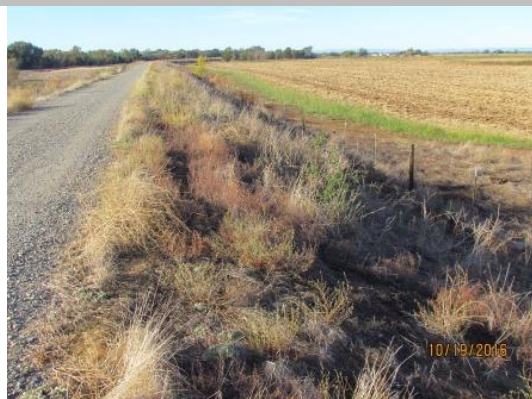
Photo 1 of 1 : FA\_2016\_RD0817\_14\_16\_20161025\_00028.jpg

LM Start	0.25	Rating **	M	Issue No.	16
LM End	1.27	Issue Type +	Ma	Location *	LS
Category	Earthen Levee			GPS Latitude/Longitude	
				Start	End
Item	Vegetation			38.987626 °	38.996896 °
				-121.506567 °	-121.491925 °
DWR ID	DWR_RD0817_03_f_2016_16				
Comment Code					
V1 : Control annual grass and weeds on the levee slopes and easements.					
Inspector Comment					
Annual grasses need to be maintained. Fall 2016.

View of annual grasses that need to be maintained on the landside looking downstream. Fall 2016.

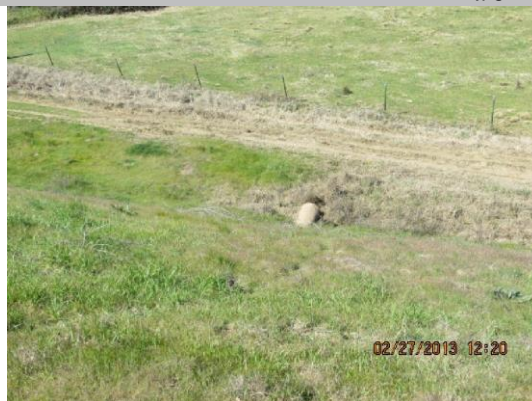
Photo 1 of 2 : UCIP\_FA\_2016\_50231\_54271.jpg

Pipe at LS toe

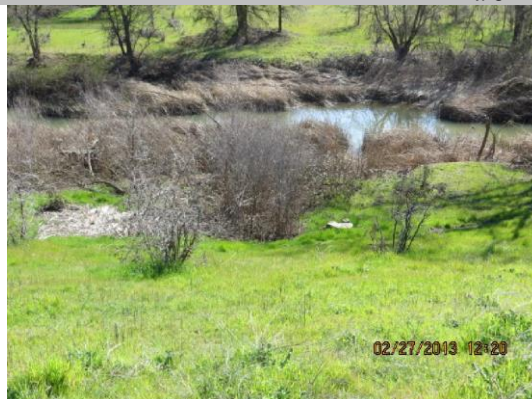
Photo 2 of 2 : UCIP\_FA\_2016\_50231\_54270.jpg

Outlet in brush at WS toe.

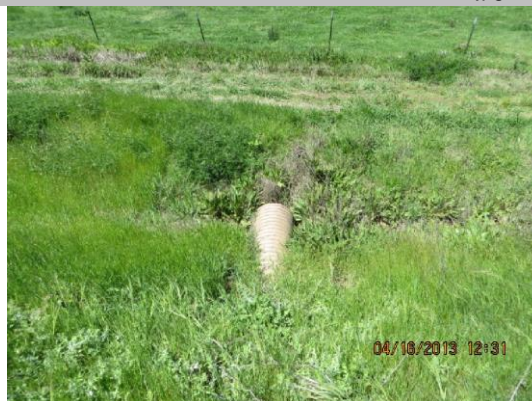
Photo 1 of 2 : UCIP\_FA\_2016\_42686\_19927.jpg

LS- overview of CM drainage pipe on toe of the levee.

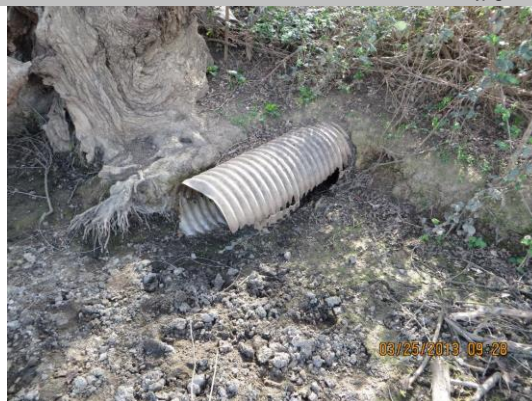
Photo 1 of 2 : UCIP\_FA\_2016\_50230\_53849.jpg

Pipe on LS toe corroded through.

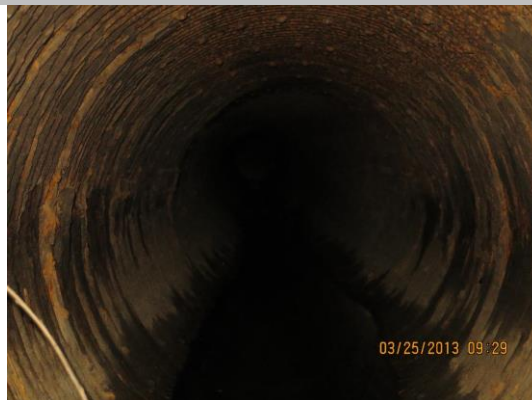
Photo 2 of 2 : UCIP\_FA\_2016\_50230\_53848.jpg

Pipe Heavily corroded throughout

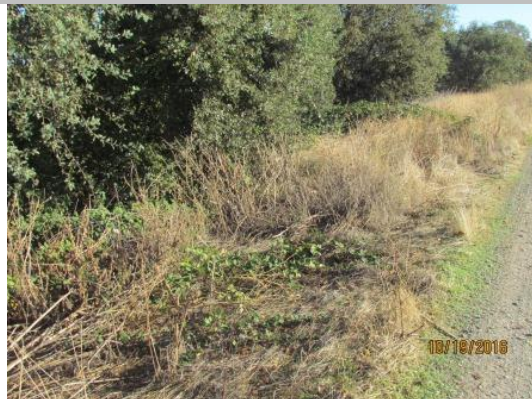
Photo 1 of 1 : FA\_2016\_RD0817\_14\_8\_20161025\_00036.jpg

View of blackberry bushes that have taken over the landside slope looking upstream. Fall 2016.

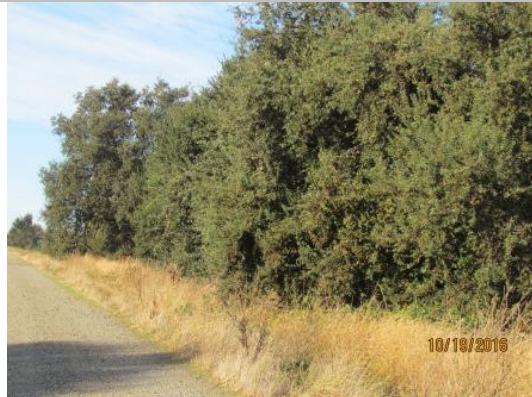
Photo 1 of 1 : FA\_2016\_RD0817\_14\_4\_20161025\_00035.jpg

View of trees that need limbs to be trimmed for access and visibility, Fall 2016.

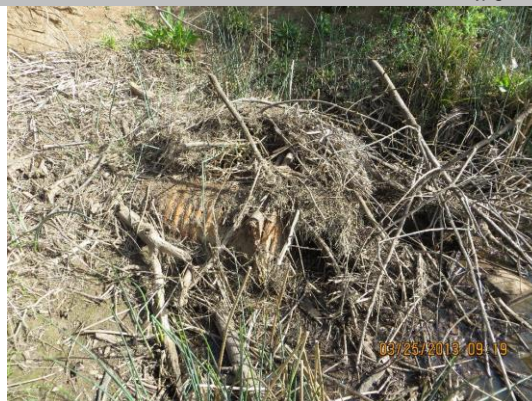
Photo 1 of 2 : UCIP\_FA\_2016\_50232\_53854.jpg

Pipe and flapgate at WS toe blocked by debris.

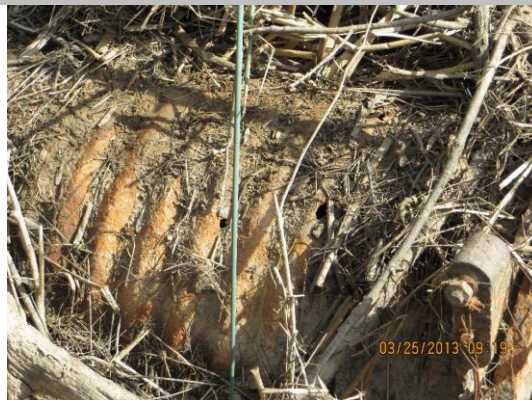
Photo 2 of 2 : UCIP\_FA\_2016\_50232\_53853.jpg

Holes in pipe at broken flapgate on WS toe.

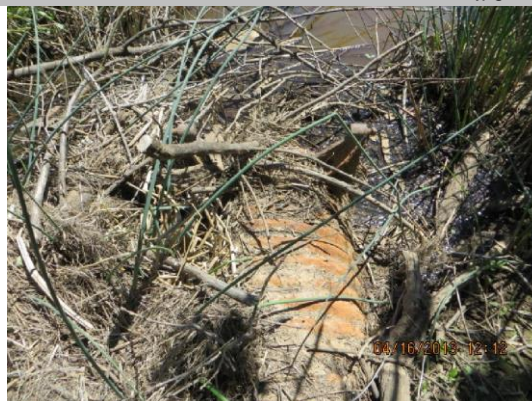
Photo 1 of 2 : UCIP\_FA\_2016\_41163\_19942.jpg

WS- CM pipe, flap gate and debris.

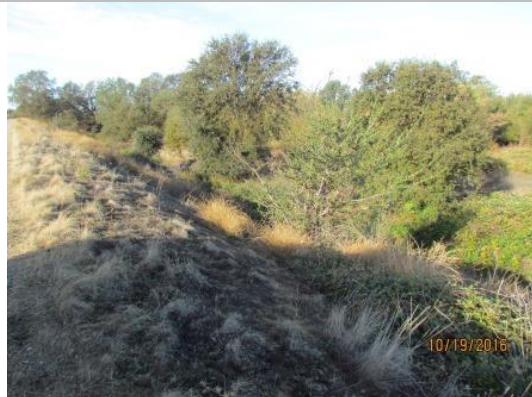
Photo 1 of 1 : FA\_2016\_RD0817\_14\_19\_20161025\_00034.jpg

View of trees that need limbs to be trimmed for access and visibility, Fall 2016.

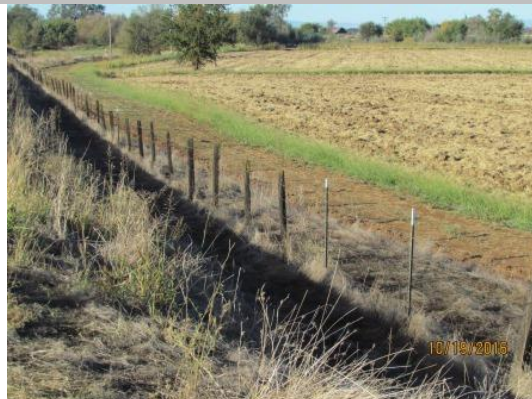
Photo 1 of 1 : FA\_2016\_RD0817\_14\_15\_20161025\_00033.jpg

View of fence at landside toe looking downstream. Fall 2016.

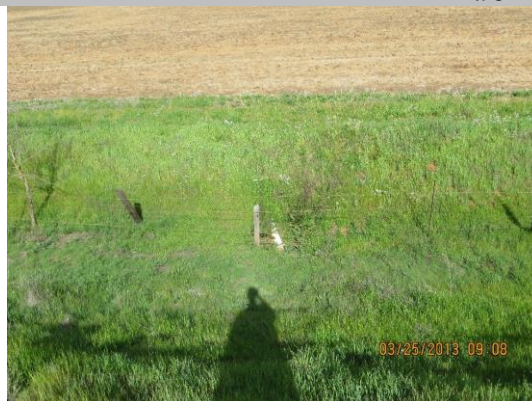
Photo 1 of 2 : UCIP\_FA\_2016\_50234\_53857.jpg

Pipe on LS toe with 8-inch PVC pipe sticking out.

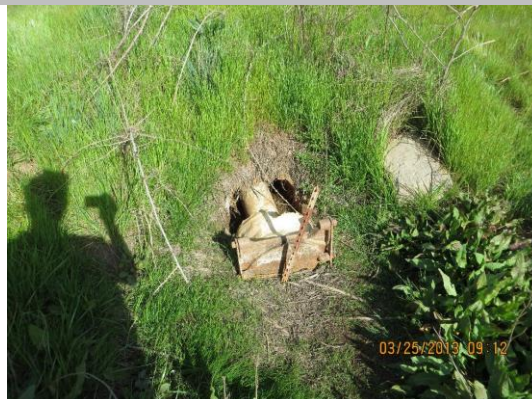
Photo 2 of 2 : UCIP\_FA\_2016\_50234\_53856.jpg

Pipe cut behind flap gate on WS toe with 8-inch PVC.

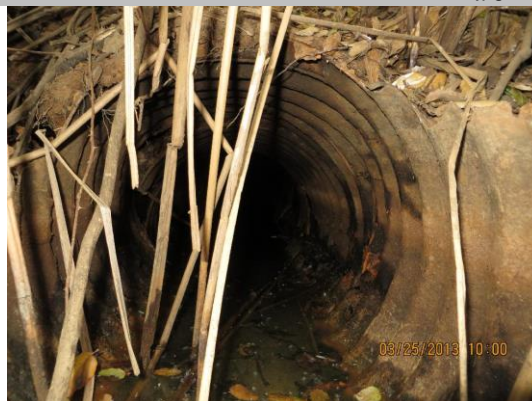
Photo 1 of 2 : UCIP\_FA\_2016\_50235\_53859.jpg

Pipe at inlet on LS toe.

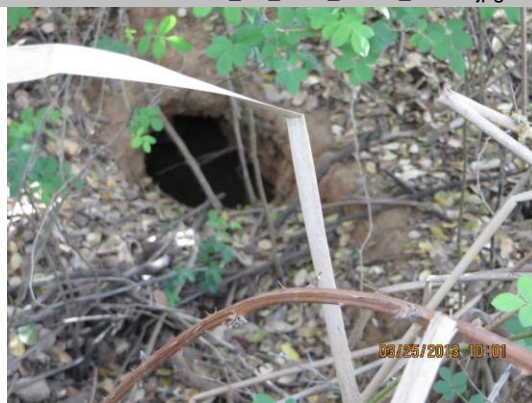
Photo 2 of 2 : UCIP\_FA\_2016\_50235\_53858.jpg

Sinkhole or animal burrow over pipe on LS toe.
